PA-2A Won't Ring After a Change in Phone Service

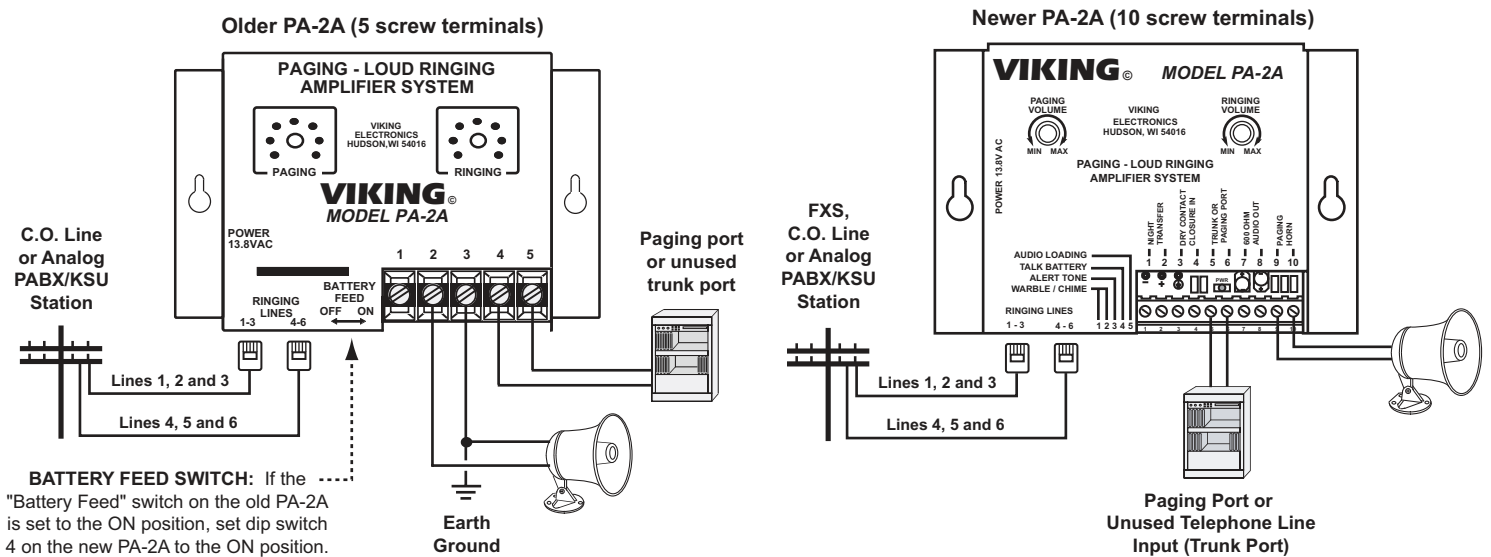
Thousands of older PA-2A's with 5 screw terminals are still in use. As users of these older PA-2As update their phone service (cable, VoIP, channel bank, etc.), the loud ringing feature of these units will often stop working. These 5 screw terminal type had "earth ground" referenced ring detection. When the phone line comes from any other source, the ring signal may no longer have this earth ground reference and the PA-2A won't detect ring. To get this feature working again, replace the PA-2A with a current version (10 screw terminals), where no earth ground reference is required.
